# The San Diego Real Estate Inspection Company

## Home Inspection Report

<b>Date:</b> 7/8/2011	<b>Time:</b> 01:00 PM	<b>Report ID:</b> 110708-52
<b>Property:</b>	<b>Client:</b>	<b>Real Estate Professional:</b>

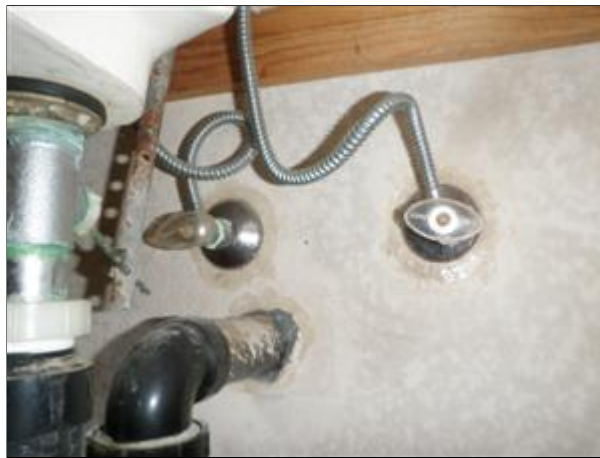
2.2 Picture 1

(1) One piece valve/flexible supply lines are installed at some or all sinks and toilets. These supply pipes are know to corrode from the inside and fail. Corrosion/calcification was observed at these valves which indicates that corrosion is taking place. I recommend replacing all of these older angle stop valves with new valves and braided steel supply lines to avoid leaks.

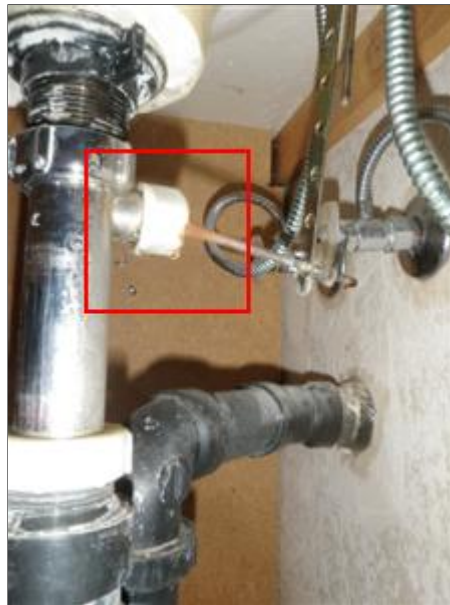
2.2 Picture 2

(2) A leak was observed at the master bath sink drain, right side. Advise corrections with licensed plumber.

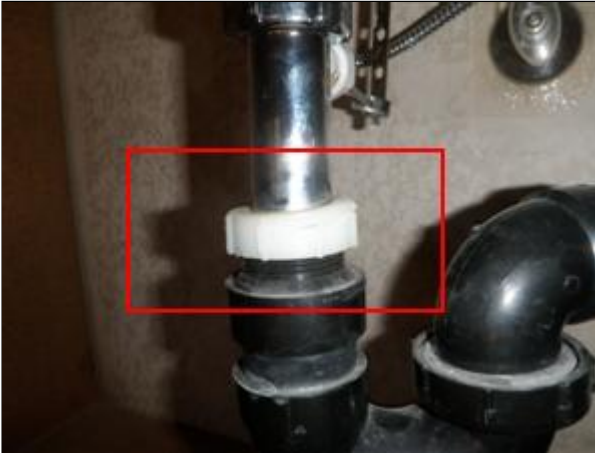
2.2 Picture 3

(3) A cracked drain fitting was observed under the master bath sink (Left side) Advise replacement.

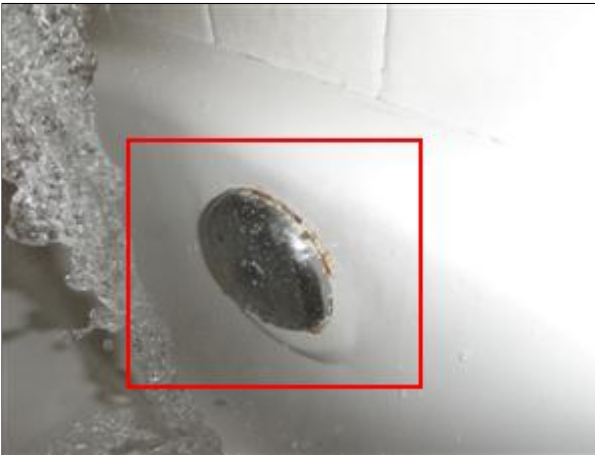
2.2 Picture 4 Hall bath

(4) The hall bathroom tub overflow drain components are corroded. This can indicate that additional corrosion is occurring behind the tub which cannot be determined. Recommend having a licensed plumber inspect and replace parts, which may include the tub, as necessary to prevent leaks.

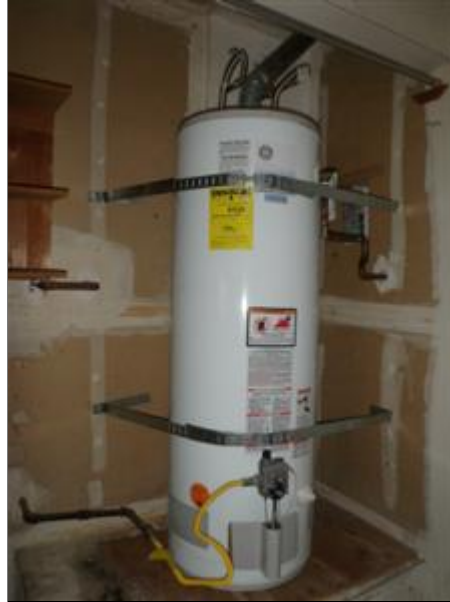
2.4 Picture 1

(1) Picture of water heater. Functional at time of inspection. No leaks observed.

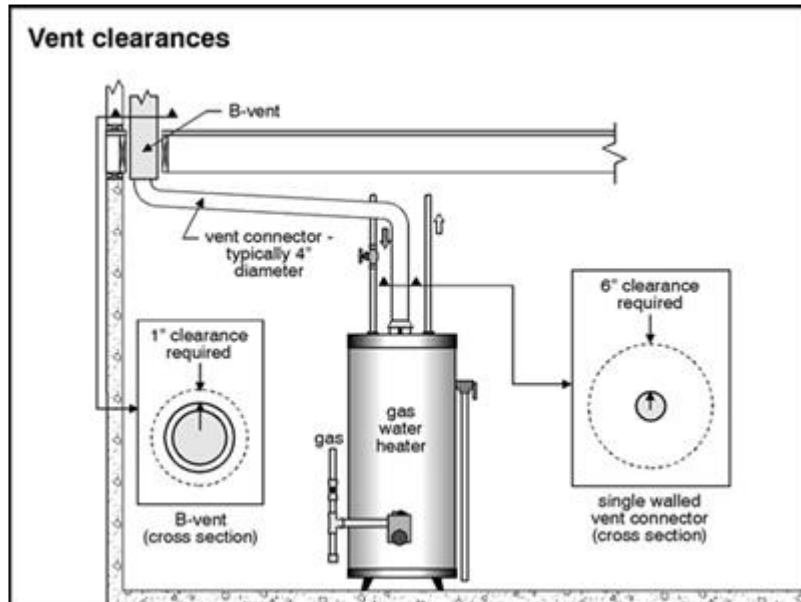
2.4 Picture 2

(2) Insufficient clearance at water heater flue. With a single wall flue, a 6 inch clearance must be maintained between flue and combustible materials. Recommend correction by a licensed contractor.

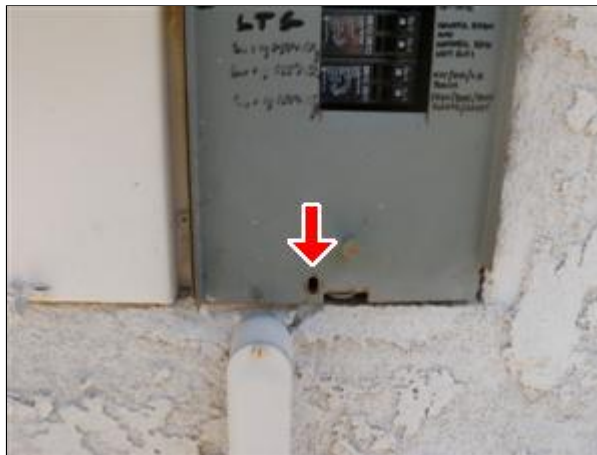
3.0 Picture 1

The panels screw is missing at the electric panel. Advise installing screw(s) for safety.

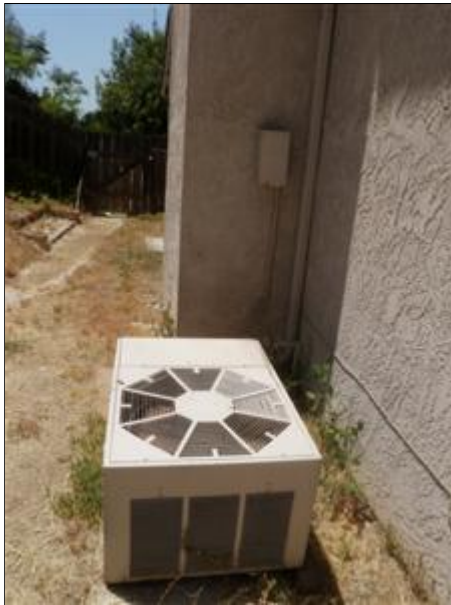
5.3 Picture 1

(1) Ambient air test was performed by using thermometers on air handler of air conditioner to determine if the difference in temperatures of the supply and return air is between 14 degrees and 22 degrees which indicates unit is cooling as intended. The AC was tested and was found to be operating within proper operating range. This indicates that the AC is cooling properly. We do recommend an annual tune-up by a qualified HVAC contractor.

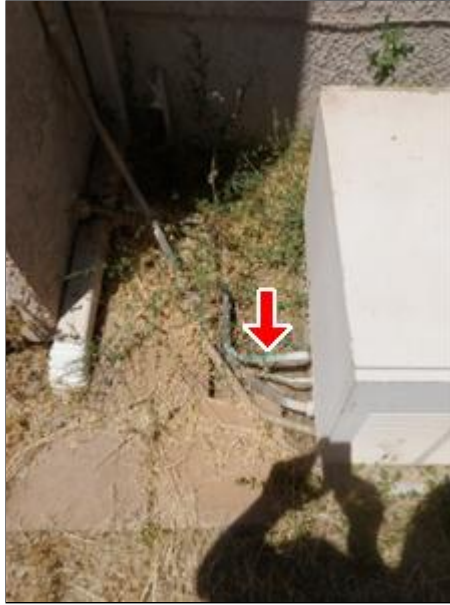
5.3 Picture 3

(2) The insulation is deteriorated or missing at the refrigerant lines. Recommend replacing the damaged insulation.

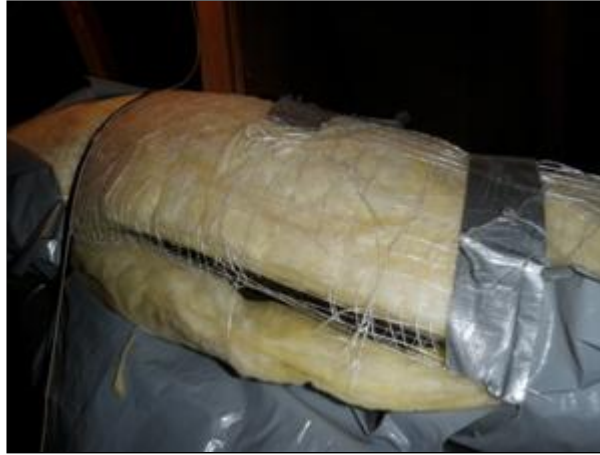
5.5 Picture 1

(1) Some of the ductwork has been damaged by exposure to UV rays (sunlight) through the roof vents. UV rays deteriorate the plastic sleeve around the duct allowing the insulation layer to fall away from the duct, reducing efficiency. I recommend further evaluation and repair by a licensed HVAC contractor.

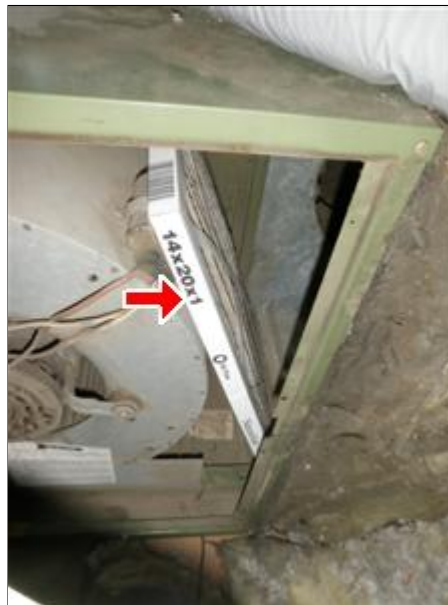
5.5 Picture 2

(3) The spring used to hold the filter in place is missing. This prevents the filter from adequately filtering the air and can allow dust to enter the ducting. Advise having the spring replaced by a qualified heating contractor to avoid contaminating the ducts. Also, the screw for air filter door is missing. Advise replacement.

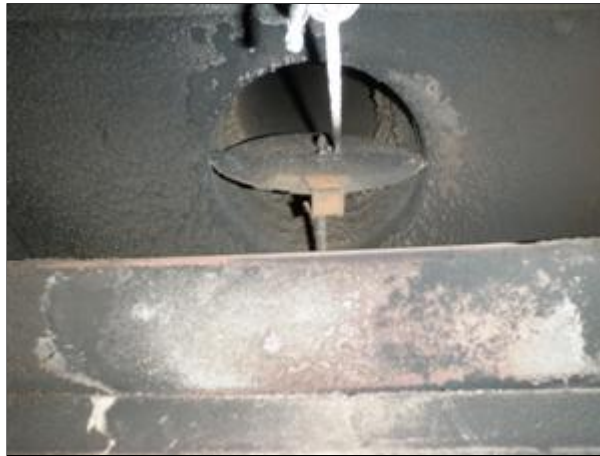
5.6 Picture 1

(2) Creosote/soot build-up noted at chimney. We advise obtaining a professional cleaning.

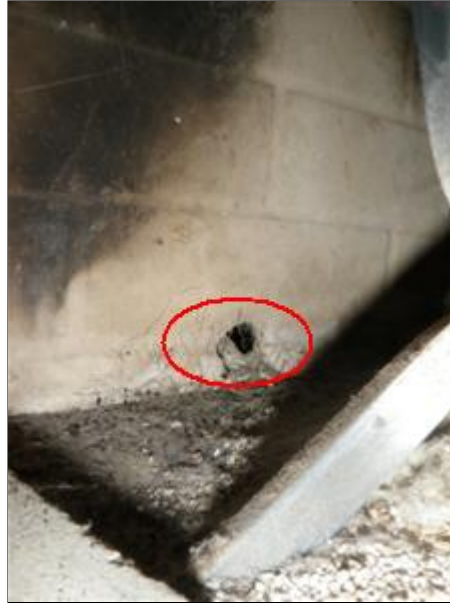
5.6 Picture 2

(3) A hole was observed at the gas stub inside fireplace. This should be sealed with an approved sealant to prevent chimney fires. We advise corrections by a licensed chimney sweep.

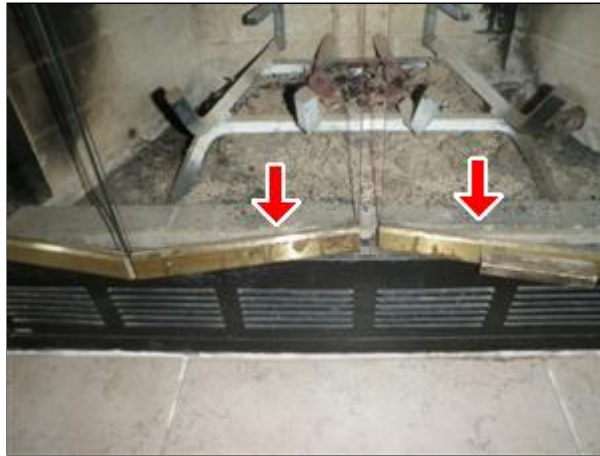
5.6 Picture 3

(4) The fireplace doors are off track. A handle is missing. We advise repair or replacement as necessary.

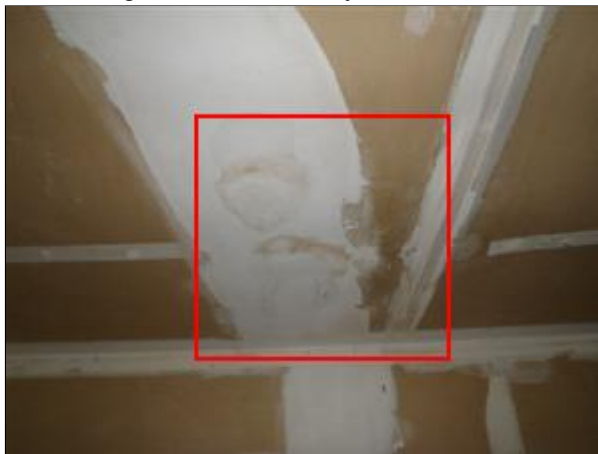
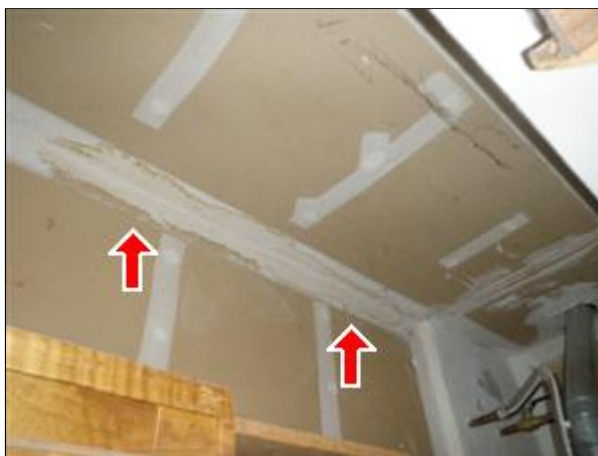
(2) Water stain(s) noted at the ceiling in the garage above water heater area. No elevated level of moisture was detected. The stain was dry at time of inspection so I could not determine if the leak is still active. Under certain conditions or regular use there may be an active leak.

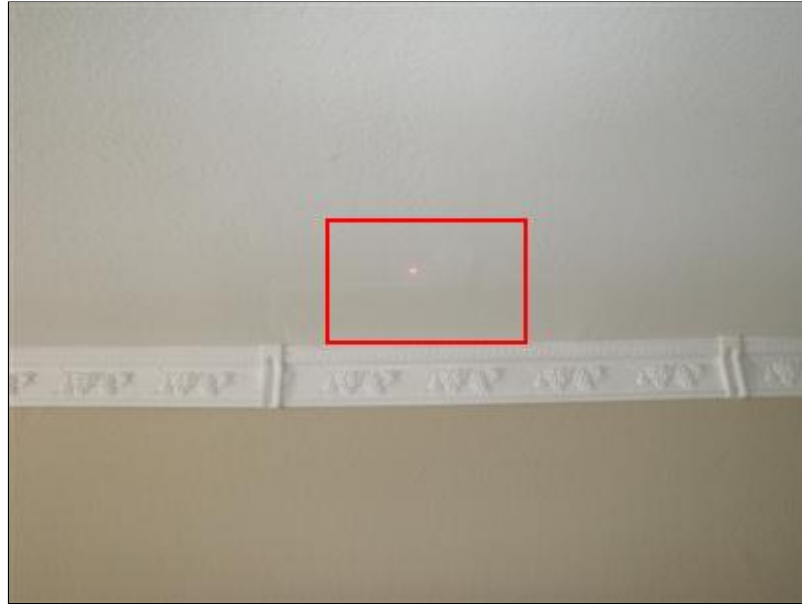
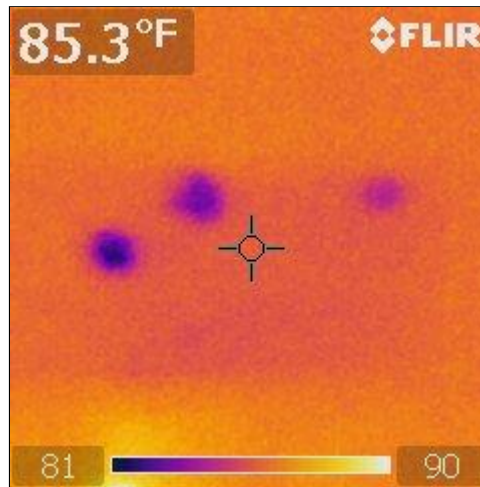
Leaks were observed, possibly from tub/showers, see section 6.1.

(3) An elevated level of moisture/plumbing leak was detected at the ceiling beneath the Hall bathroom. The exact cause of the moisture, or the presence of damage, cannot be determined without more destructive testing. There may be moisture damage behind the sheetrock which is concealed, and cannot be identified within the scope of a home inspection. To determine if moisture damage exists inside the walls, a more invasive inspection is required. This appears to be coming from the Hall bath tub/shower, possibly tub drain/overflow. Recommend further evaluation by a licensed plumber and remediation contractor to determine the extent of repairs needed.

6.1 Picture 3 Leak above fire place

6.1 Picture 4 View of leak in Living room

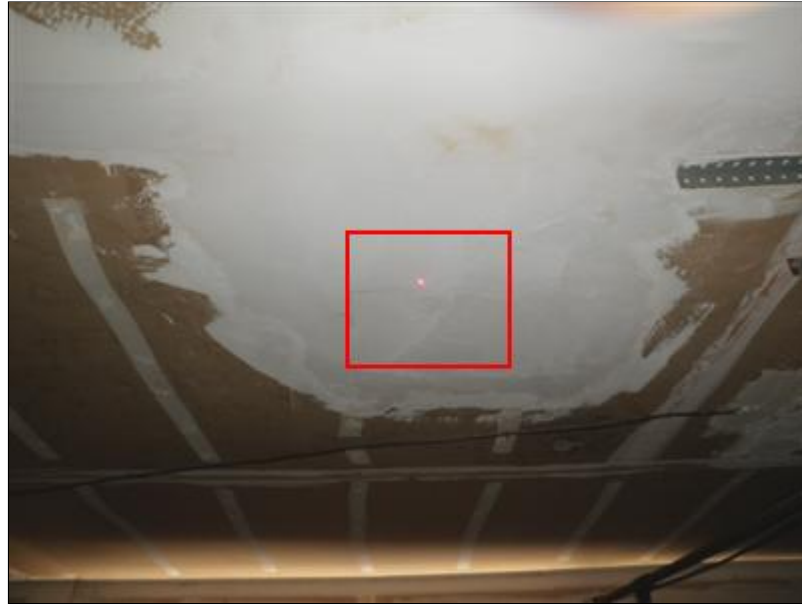
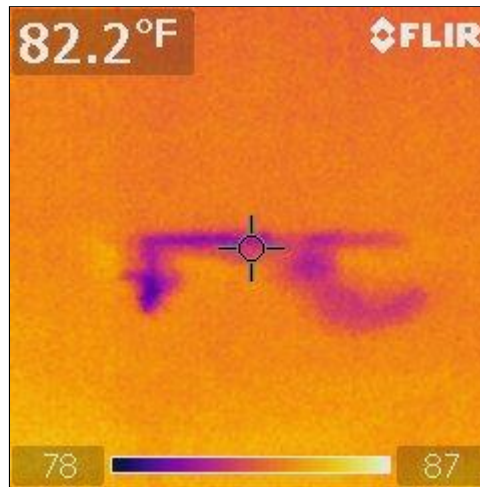
(4) An elevated level of moisture/plumbing leak was detected at the ceiling beneath the Master Bath. The exact cause of the moisture, or the presence of damage, cannot be determined without more destructive testing. There may be moisture damage behind the sheetrock which is concealed, and cannot be identified within the scope of a home inspection. To determine if moisture damage exists inside the walls, a more invasive inspection is required. This appears to be from the tub/shower possibly from tub/shower drain/overflow. Recommend further evaluation by a licensed plumber and remediation contractor to determine the extent of repairs needed.

6.1 Picture 5 Leak below master tub/shower in Garage

6.1 Picture 6 View of leak in Garage

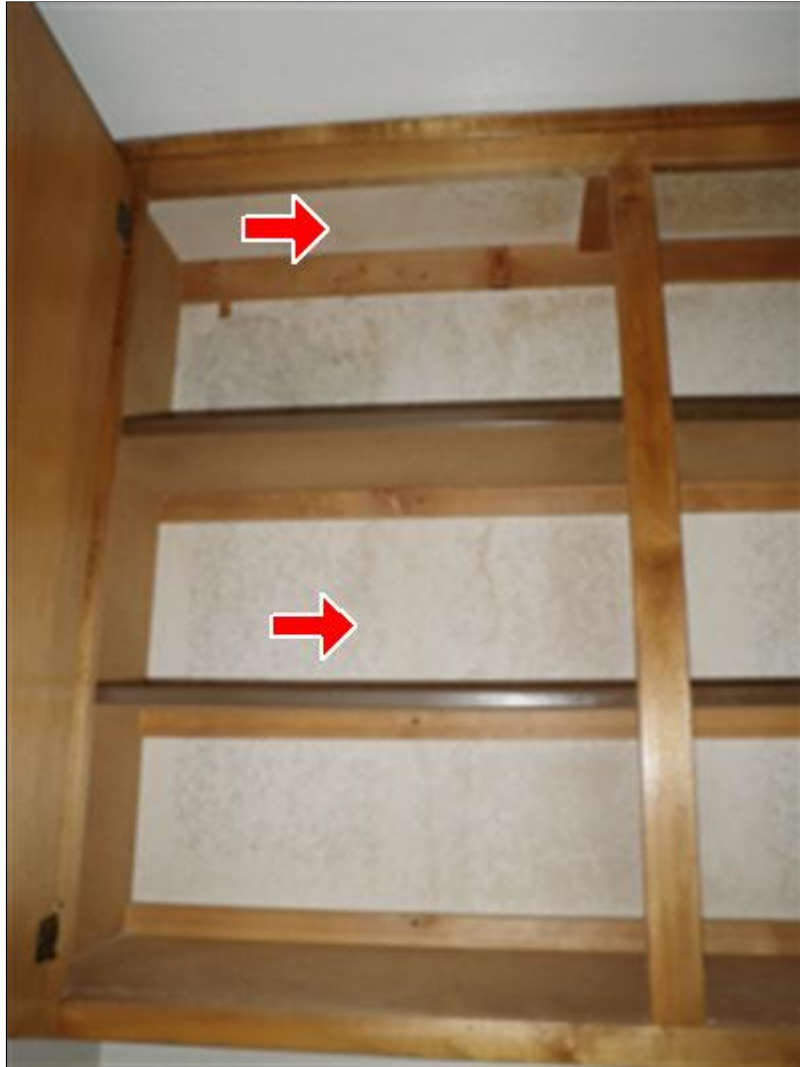
(1) Staining noted in the Hall Bath cabinet. The staining was dry at time of inspection so I could not determine if the leak is still active. Under certain conditions or regular use, the leak may become active. Possibly due to AC condensation leak or roof leak. This staining is below the AC condensation drain lines in attic, repairs have been made to the drain lines. Recommend further evaluation by a licensed roofer and HVAC contractor.

6.2 Picture 1 Hall cabinet next to bath

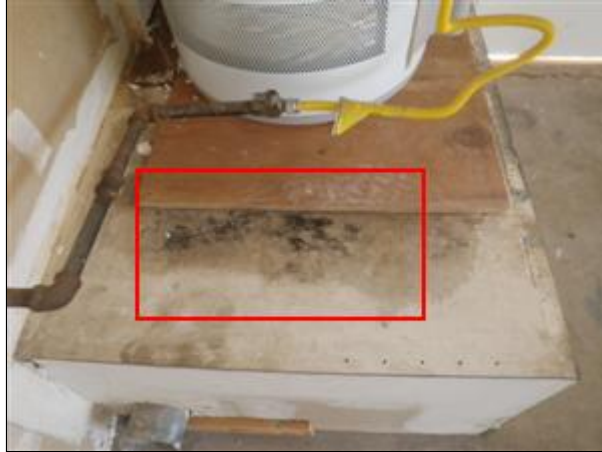
6.2 Picture 2

(2) Dark stains were observed on the Sheetrock in the garage (at water heater platform) which may indicate the presence of organic growth or mildew. This is most likely caused by a water heater leak. (Possibly from old water heater) No leaks observed at time of inspection.

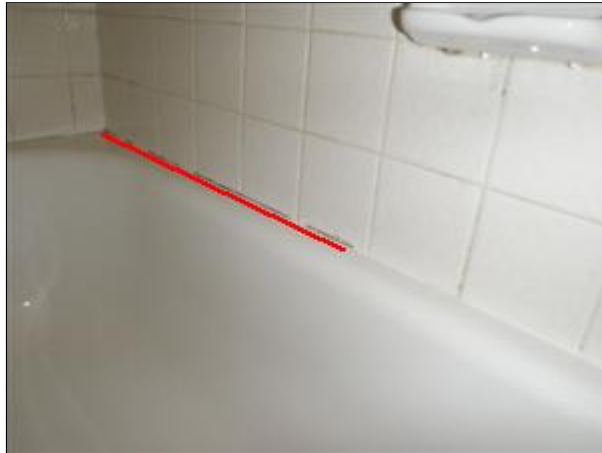
6.4 Picture 1 Hall bath

Caulking is required around perimeter of the hall bathroom tub and tiles to prevent water intrusion.

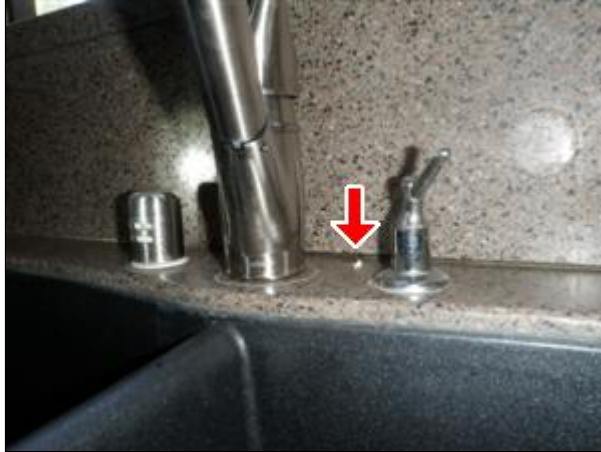
6.6 Picture 1

(1) Advise caulking at the counter/sink/back splash to prevent water from leaking below the sink.

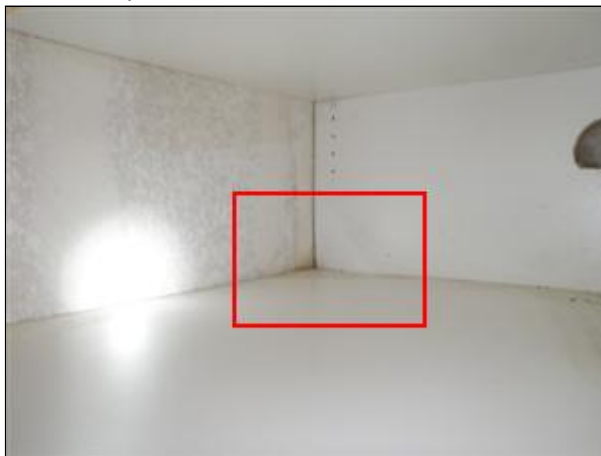
(2) Water stains observed under the kitchen sink cabinet. An elevated level of moisture was detected. (Reading confirmed with moisture meter) No leaks were observed at this location. Appears to be from an old leak. Advise review with licensed plumber/seller.

6.6 Picture 2 Left of sink kitchen base cabinet

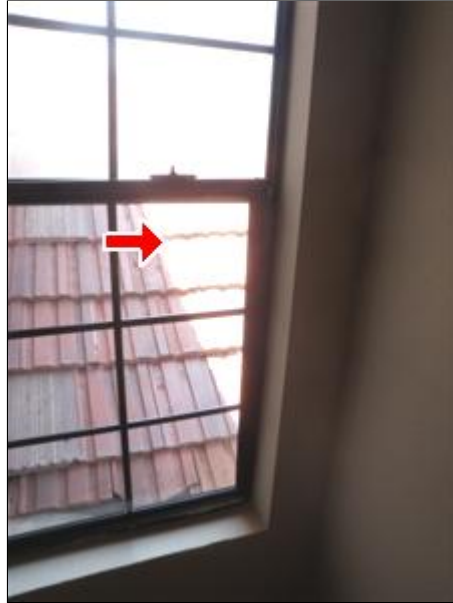
6.8 Picture 1

The 2nd bedroom window sash spring was broken. The window does not open/close. Advise corrections with licensed window contractor.

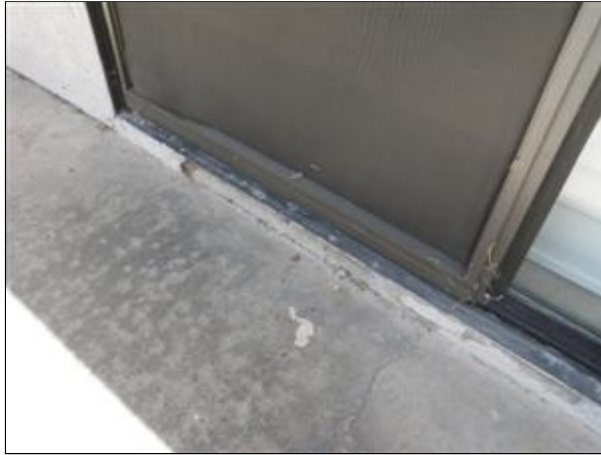
8.4 Picture 1

(1) Metal threshold at sliding door noted deteriorated, mainly due to mineral deposits in the concrete slab. We advise replacing the threshold.

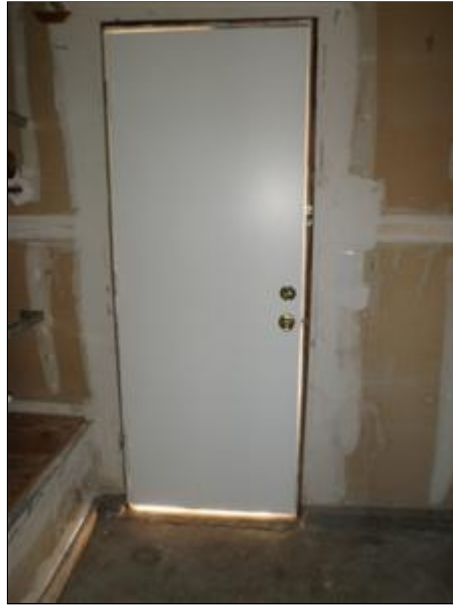
8.4 Picture 2

(2) The side entry door to garage is missing weather stripping and threshold, this door may allow water to enter the garage. Advise repair with qualified person.

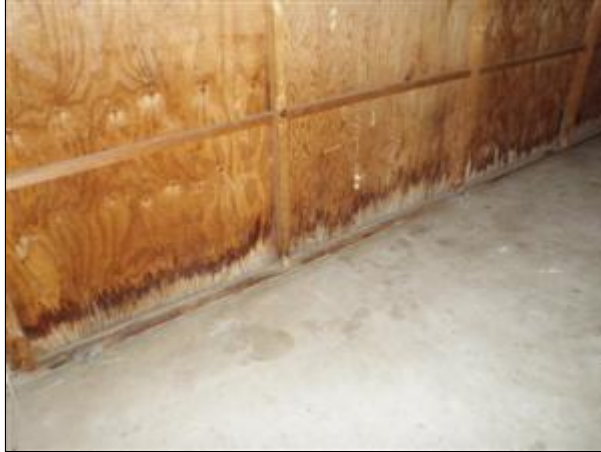
8.6 Picture 1

Water damage observed at base of garage door. Door was manually functional at time of inspection.

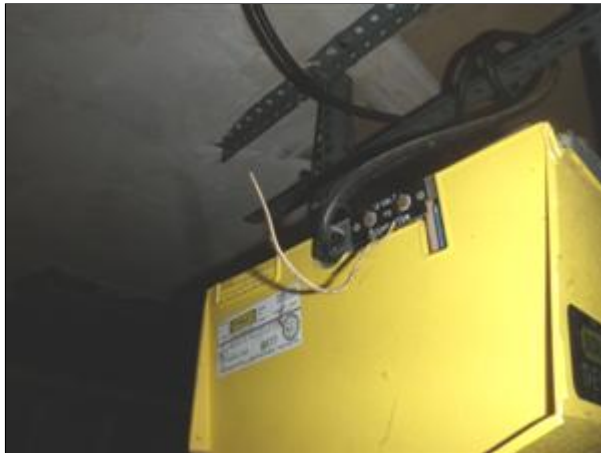
8.7 Picture 1

Garage door opener(s) in place but not operational. Advise further inspection by a qualified garage door service contractor.

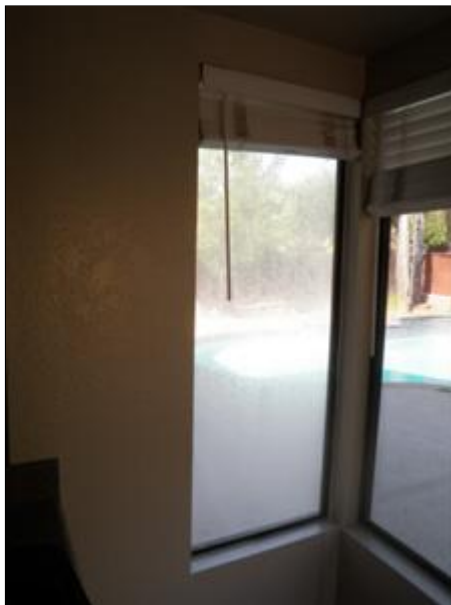
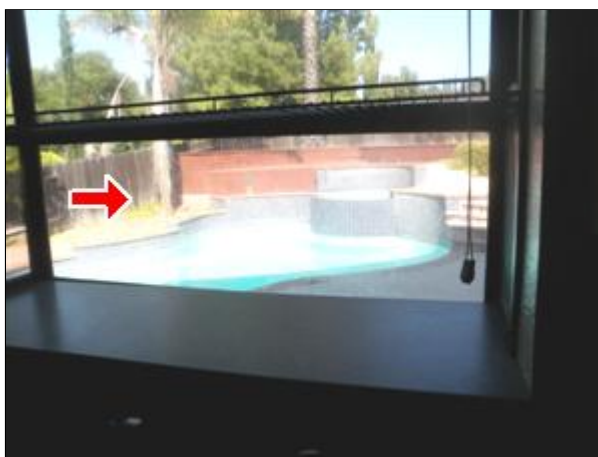
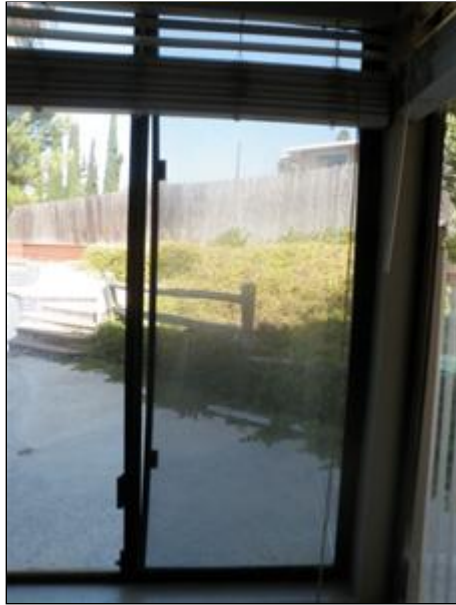
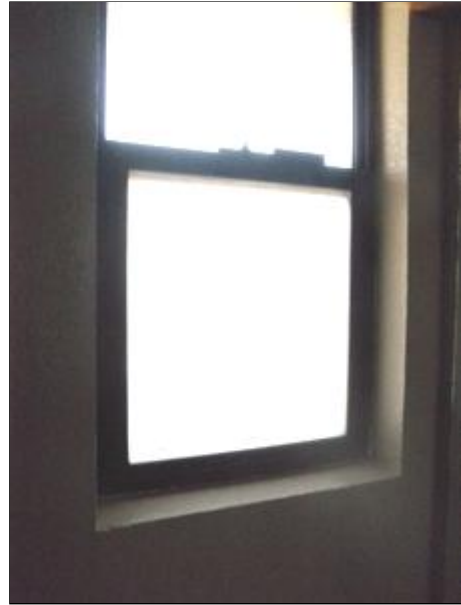
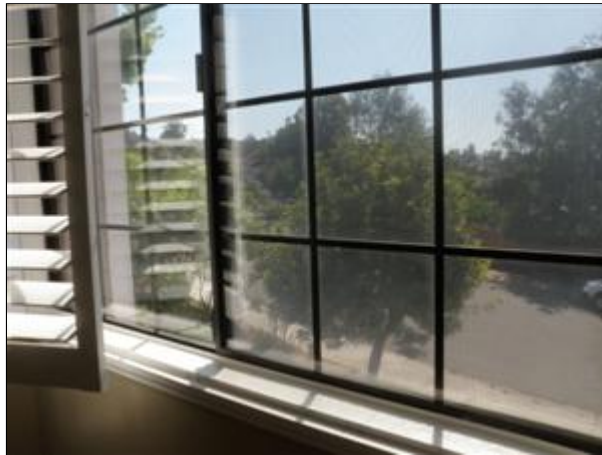
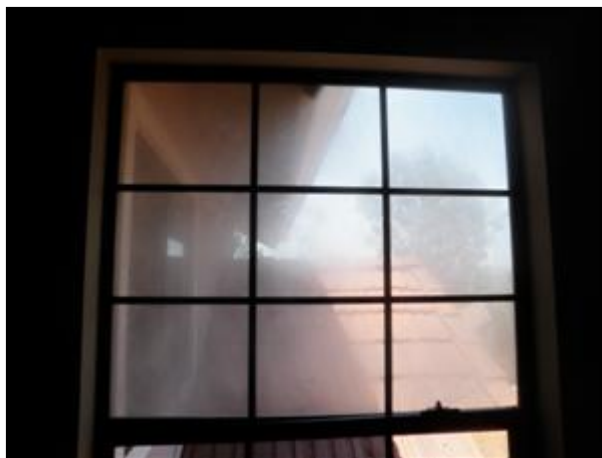
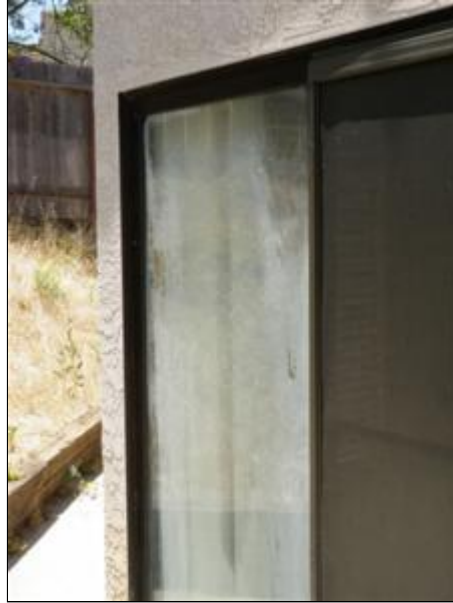
Six windows and one slider door were observed with condensation/fogging between the panes of glass. Condensation in double glazed thermal window panes will reduce visibility and insulating capability. To restore visibility and regain the insulating capability, replacement of the insulated unit or window is required.

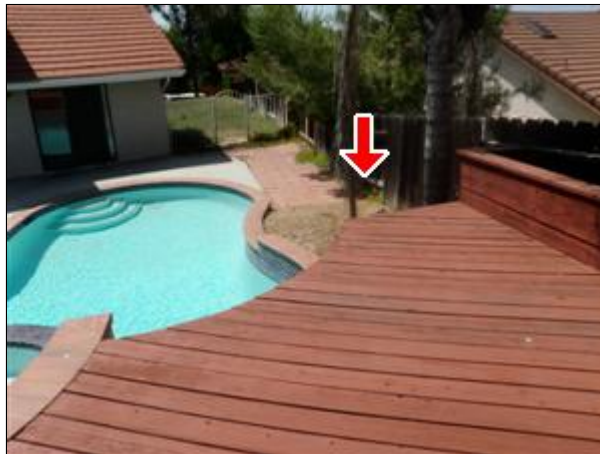
8.9 Picture 1

(1) A railing (guard rail) is required at the deck to prevent injury. The deck is greater than 24 inches from the ground below. Advise obtaining a quotation from a qualified contractor prior to the end of your contingency period.

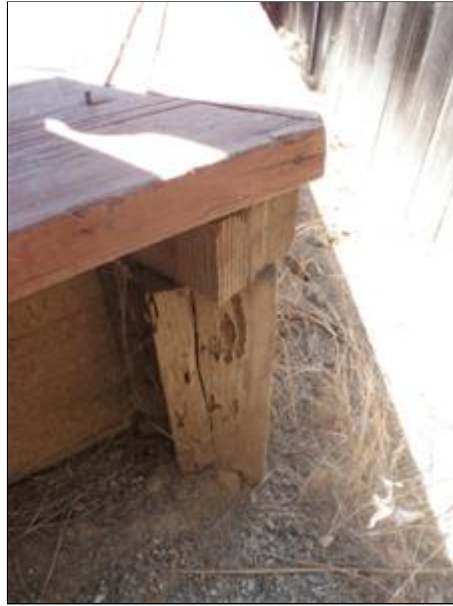
8.9 Picture 2

(2) Wood deck is in contact with ground at pool (Rear yard) . This can cause deterioration and attract wood eating insects. You should refer to the pest inspection report for a complete evaluation. Home inspectors do not have the authority to comment on termites or dry rot, which is the responsibility of a state licensed pest inspector.

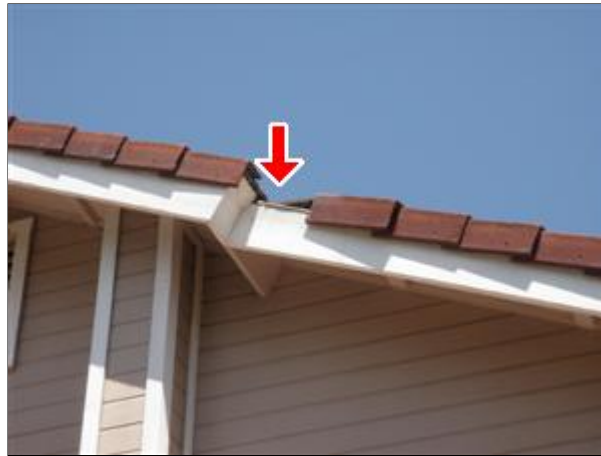
(1) Tile roof covering was inspected from the ground and attic to avoid damaging the roof covering. This is in accordance with the CalNACHI standards of practice. The entire roof was not visible. Several slipped or missing tiles observed.

9.0 Picture 1 Missing tile

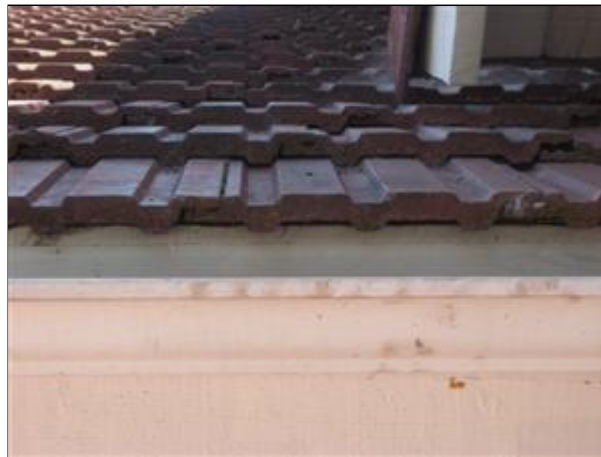
9.0 Picture 2

(2) The tile roof is 20 years old or more. Tile roofs installed in the 1980's or before may have an underlayment that is near the end of its expected life. It is important to understand that the underlayment commonly known as "tar paper" has a life span that may be limited to 25 years depending on quality of materials, installation, sun exposure, ventilation of the attic, and maintenance. No drip edge flashing was used at eaves, this can cause the eaves to rot. Replacing the underlayment can be costly. **You should have the roof evaluated by a licensed roof contractor to obtain an estimate of life remaining, or the cost of repair/replacement before the close of your contingency period.** We also recommend that you maintain a good home warranty with the additional roof coverage.

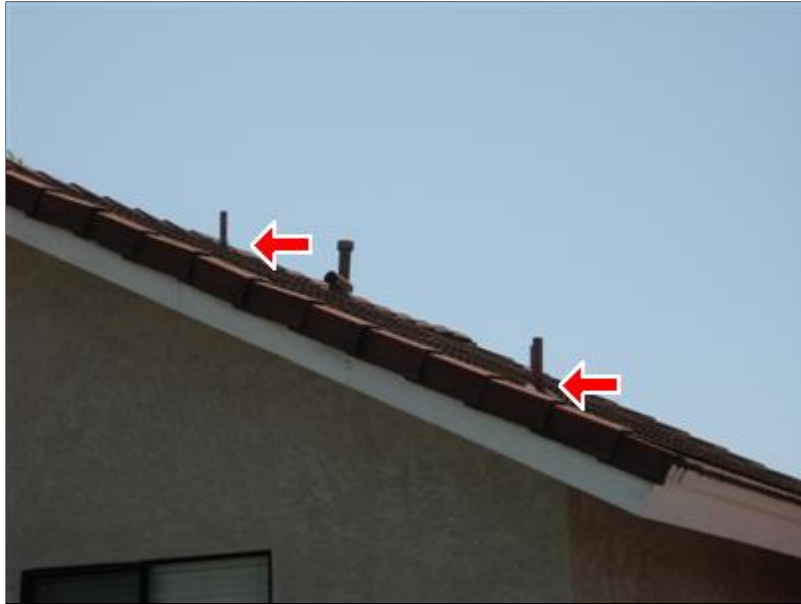
9.1 Picture 1

Mortar flashing was noted at the roof penetrations. This is an older method of sealing the roof penetrations which is no longer used. Cracks were observed at the mortar flashings which may leak during rain. (Leaks observed in attic) **Recommend having the roof inspected by a licensed roof contractor prior the end of your contingency period.**

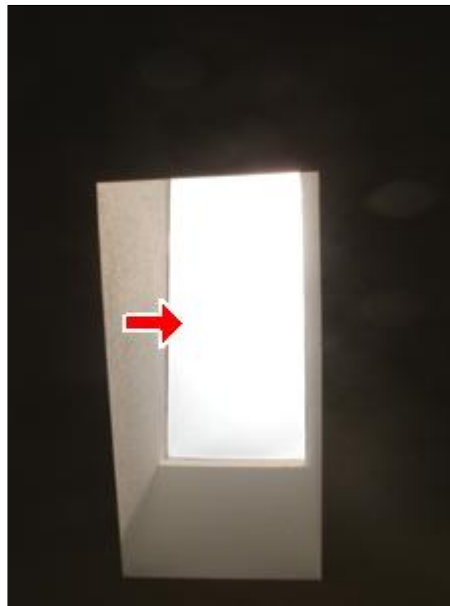
9.2 Picture 1 Master bath

Cracking (Spider cracks) was noted in the skylight above master bath. Recommend having a licensed roof contractor provide an estimate for the cost of repair or replacement prior to the end of your contingency period.

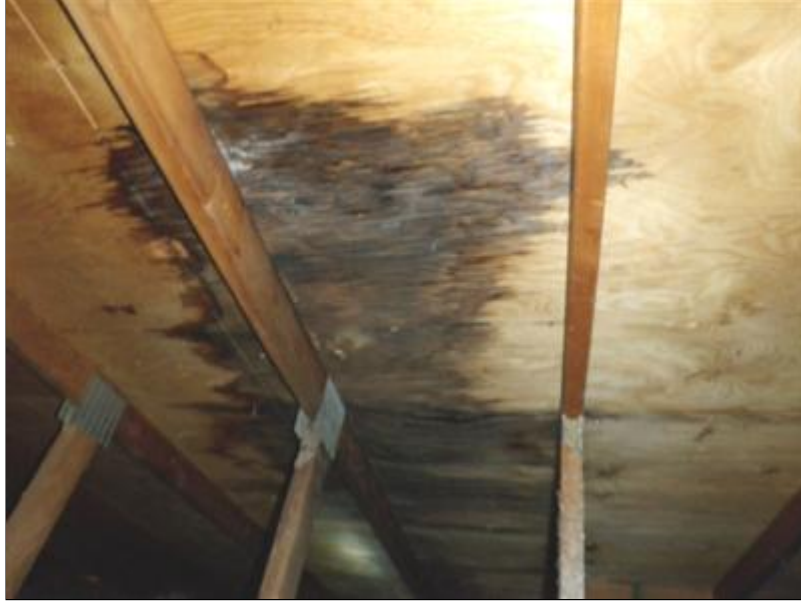
9.3 Picture 1

Stain(s) noted in the roof sheathing at various areas in attic. Due to the lack of recent rain, I was unable to determine if active or passive. The roof is in need of significant repair and likely leaks during rain. Recommend contacting a licensed roof contractor for further evaluation prior to the end of your contingency period.

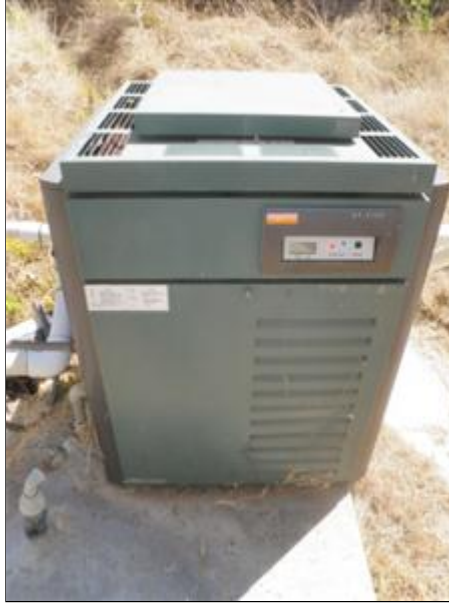
13.7 Picture 1

The pool heater was inoperable at time of inspection. No power to heater. Unable to determine cause. Advise review with licensed pool contractor for an estimate to repair or replace before the close of your contingency period.

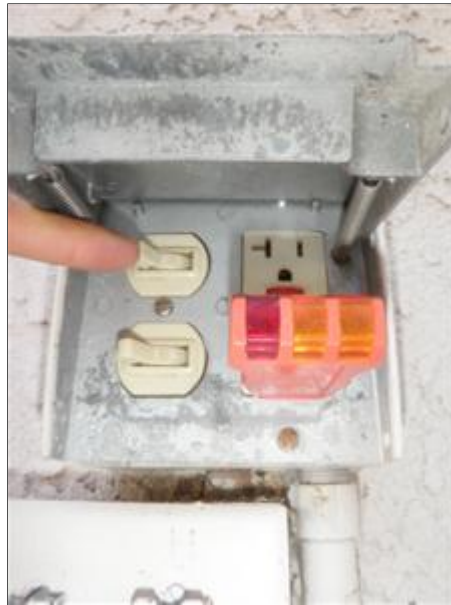
13.9 Picture 1

The GFCI outlet trips when the pool light is turned on. This indicated there may be water in the light. Advise review with licensed pool contractor for an estimate to repair before the close of your contingency period.
