# The San Diego Real Estate Inspection Company

## Home Inspection Report

<b>Date:</b> 7/8/2011	<b>Time:</b> 01:00 PM	<b>Report ID:</b> 110708-52
<b>Property:</b>	<b>Client:</b>	<b>Real Estate Professional:</b>

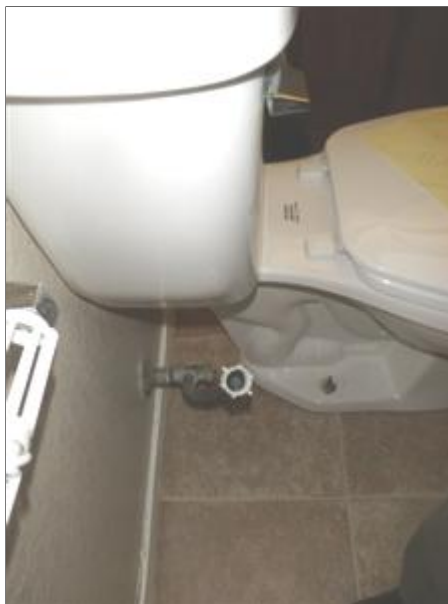
2.2 Picture 5

(5) Hall bath toilet was disconnected from the water supply at time of inspection. Advise corrections with licensed plumber

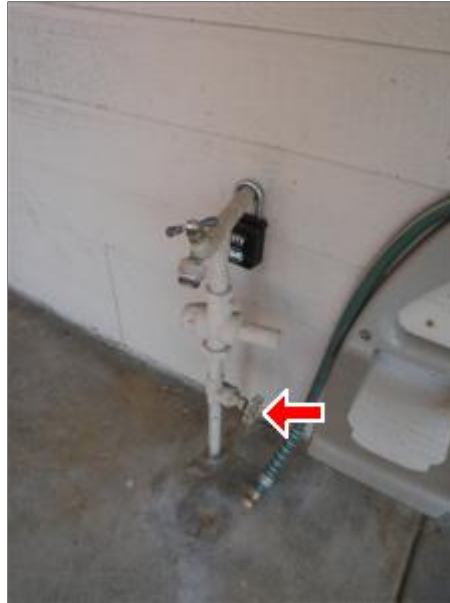
4.0 Picture 1

The main water shut off valve is located at the front exterior wall of the house.

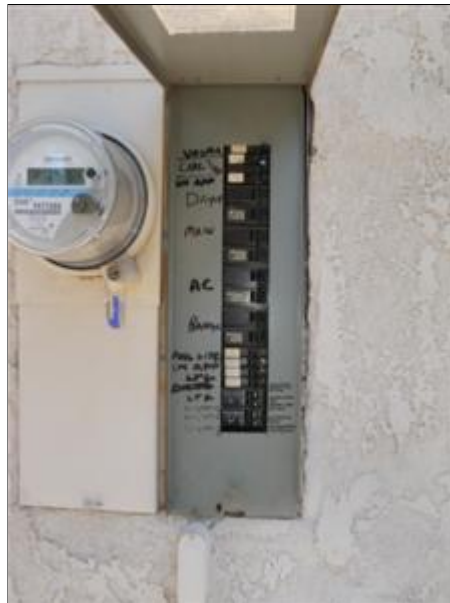
4.1 Picture 1

The main electric shut off for the dwelling is located at the right exterior (facing front).

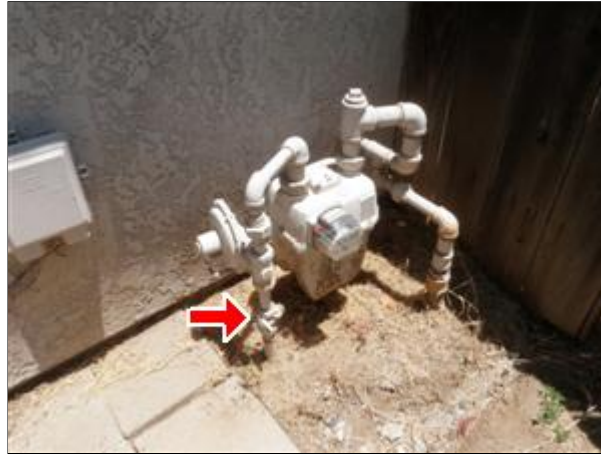
4.2 Picture 1

The main gas shut off valve is located at the gas meter at the right side of the house (facing front).

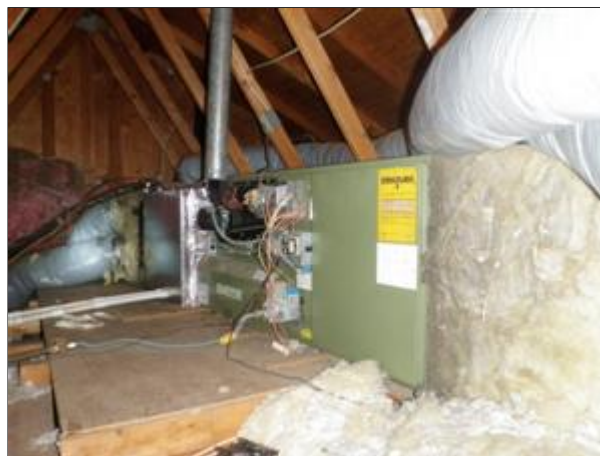
5.0 Picture 1

The furnace is old and appears to be original equipment. Functional at time of inspection. Rust noted in the burn chamber. Most heating contractor consider units over 20 years old to be at the end of their life span. Advise consulting with a heating contractor to review the system for an estimate of life remaining, and the cost of replacement prior to the end of your contingency period.

We recommend having SDG&E or a heating contractor perform an annual test each season before use.

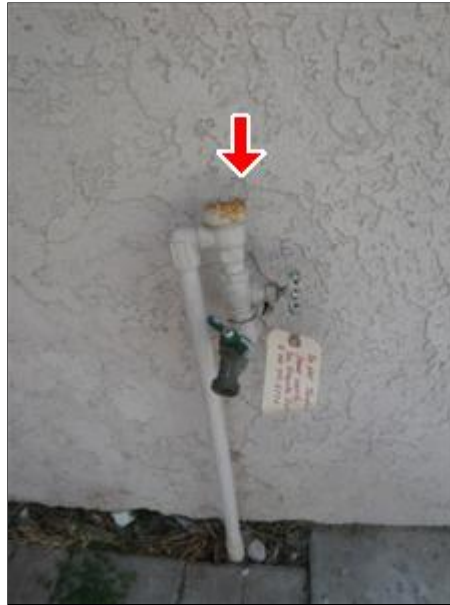
13.15 Picture 1

Pool fill.
